Contract #: 04-0120F4Cty: SF/ALA Rte: 80 PM: 13.2/13.9File #: 69.28**WELDING INSPECTION REPORT****Resident Engineer:**Siegenthaler, Peter**Address:** 333 Burma Road**City:** Oakland, CA 94607**Report No:** WIR-024944**Date Inspected:** 02-May-2011**Project Name:** SAS Superstructure**OSM Arrival Time:** 700**Prime Contractor:** American Bridge/Fluor Enterprises, a JV**OSM Departure Time:** 1900**Contractor:** Zhenhua Port Machinery Company, Ltd (ZPMC), Changxing Island **Location:** Shanghai, China**CWI Name:** Xu Le Feng /Qiu Wen**CWI Present:** Yes No**Inspected CWI report:** Yes No N/A**Rod Oven in Use:** Yes No N/A**Electrode to specification:** Yes No N/A**Weld Procedures Followed:** Yes No N/A**Qualified Welders:** Yes No N/A**Verified Joint Fit-up:** Yes No N/A**Approved Drawings:** Yes No N/A**Approved WPS:** Yes No N/A**Delayed / Cancelled:** Yes No N/A**Bridge No:** 34-0006**Component:** OBG Bike Path**Summary of Items Observed:**

WELDING INSPECTION REPORT

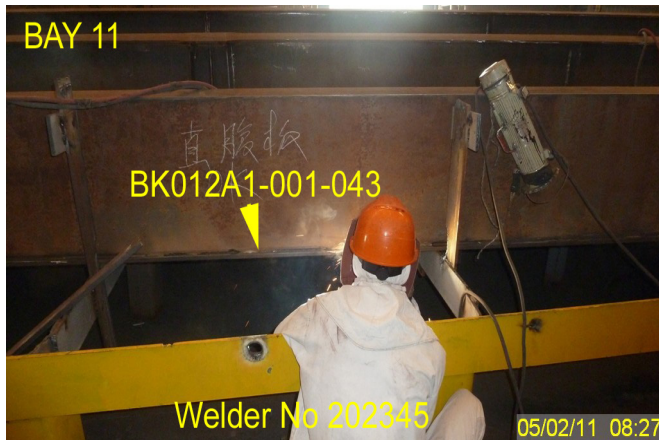
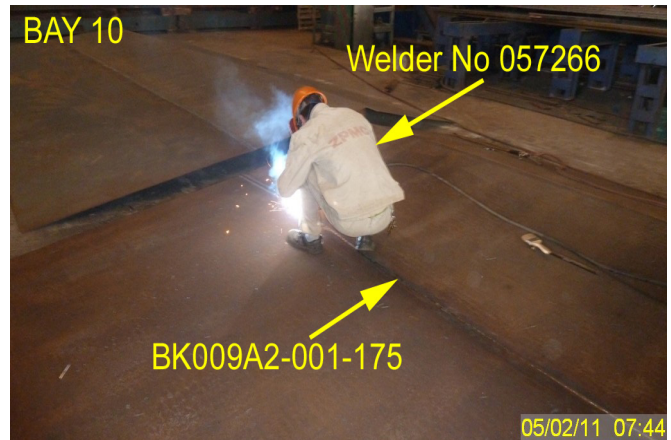
This QA Inspector observed the following work in progress: SMAW welding of weld joint 002 located on BK009A8-001. Welder is identified as 057220. ZPMC Quality Control (QC) is identified as Qui Wen. The welding variables recorded by QC appeared to comply with the Applicable WPS.

Unless otherwise noted, all work observed on this date appeared to generally comply with applicable contract

documents.
